St James the Less Church

Bat Risk Assessment

May 2011

Report Reference: 2446/BS.11

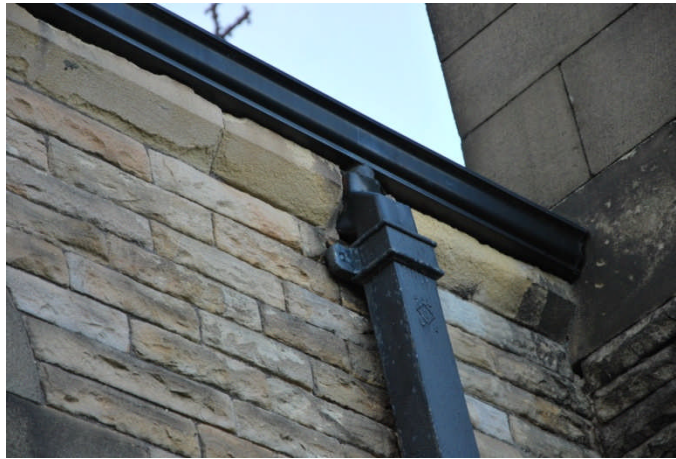
Photograph 1

Typical gaps in masonry

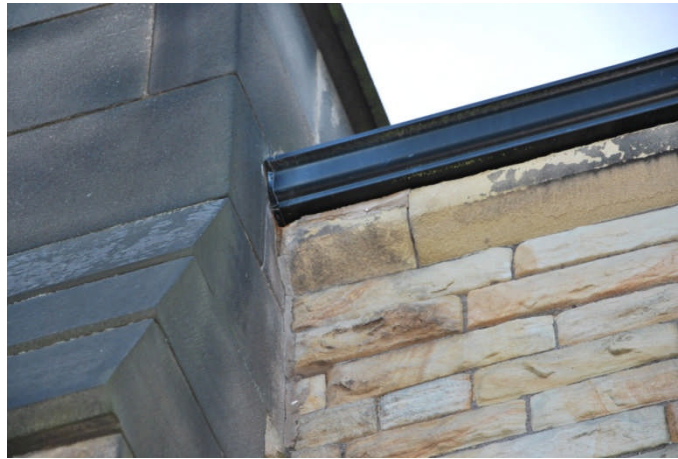
Photograph 2

Typical gaps in masonry

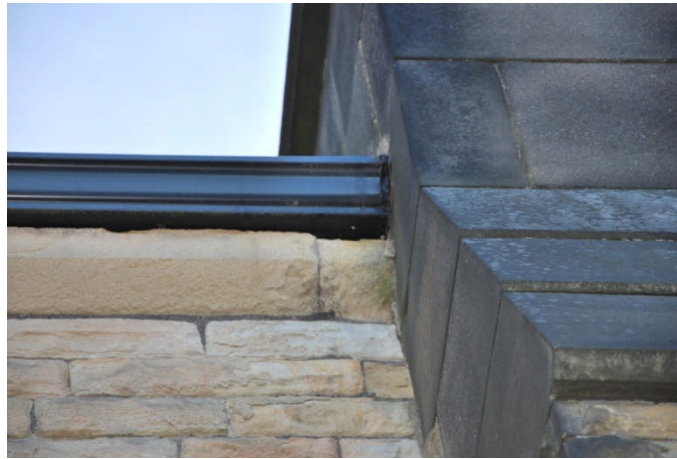
Photograph 3

Typical gaps in masonry

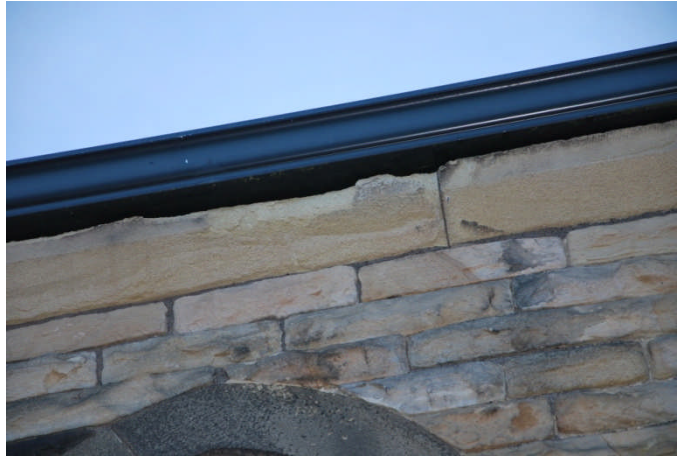
Photograph 4

Typical gaps in masonry

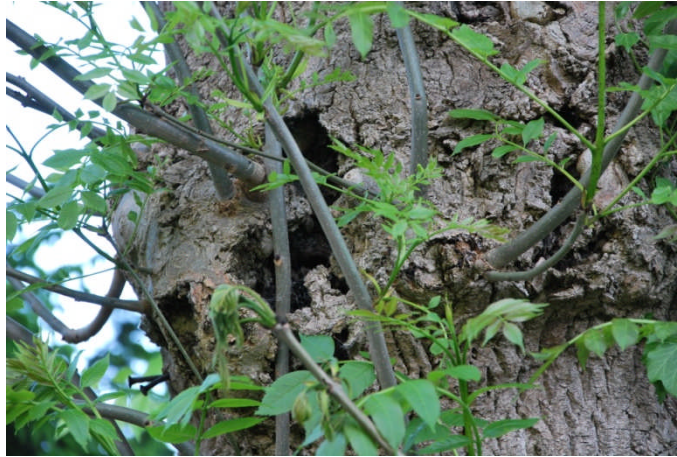
Photograph 5

3.03 Of the three trees to be removed only one – the ash, was considered suitable to have any potential as a roost. The lime and beech had no features that were considered suitable for roosting bats. The ash is a former pollard that has evidence of a significant infestation of canker with lesions on the stem. Currently, it has a stem of approximately 5 metres in height with no epicormic or other re-growth typical of pollarded trees. This appeared to have been removed and was stacked at the base. The amount of material suggests that the re-growth was not particularly dense and therefore had no potential for roosts.

Typical cracks/fissures in ash

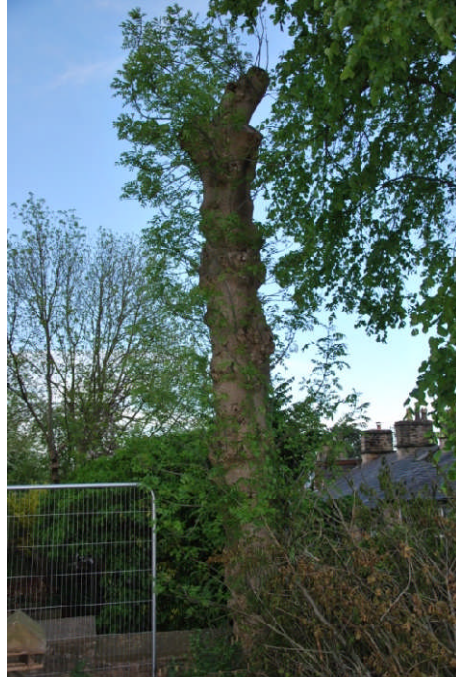
Photograph 6

Ash to be felled
